PASSAGE – OF ARCHITECTURAL PEARL OF ODESSA**ПАССАЖ - АРХИТЕКТУРНАЯ ЖЕМЧУЖИНА ОДЕССЫ****Yurkovsky R.G., / Юрковский Н.Е.***c.t.s, prof./к.т.н., проф.***Nakhmurov O.N., / Нахмуров А.Н.***c.t.s., as.prof. / к.т.н., доц.***Shishkalova N.Y., / Шишкалова Н.Е.***senior lecturer./ ст. препод.***Zakharchuk V.V., / Захарчук В.В.***senior lecturer, / ст. препод.***Kolomiets N.P., / Коломиец Н.П.***assistant / ассистент**Odessa State Academy of Civil Engineering and Architecture,**Odessa, Didrixsona 4. 65029**Одесская государственная академия строительства и архитектуры,**Одесса, ул. Дидрихсона 4, 65029*

Abstract. *In the center of the city Odessa at the intersection of Deribasovskaya and Preobrazhenskaya streets there is an architectural monument of the XIX century - "Passage". Due to changing technogenic and natural factors, the "Passage" building was constantly undergoing minor deformations. However, since 2009 the intensity of deformation of the building has increased. To study deformation processes, geodesic monitoring was organized to study the draft of the building. To quantify the sediment of the Passage building, a method of high-precision geometric leveling with the beams of the sec

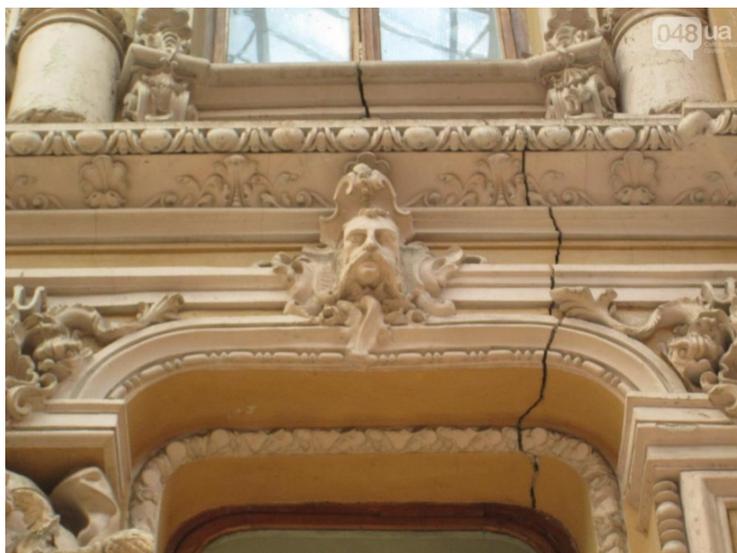
Pic 3. «Opened cracks on the facade of the "Passage"»

Основной текст In 2017, in the old building of the Odessa's "Passage", after reconstruction of water-bearing communications and foundations in 2015, reappeared the cracks. Presumed cause is soaking the loess-like soil of the base of the building and arising due to their uneven precipitation. [3]

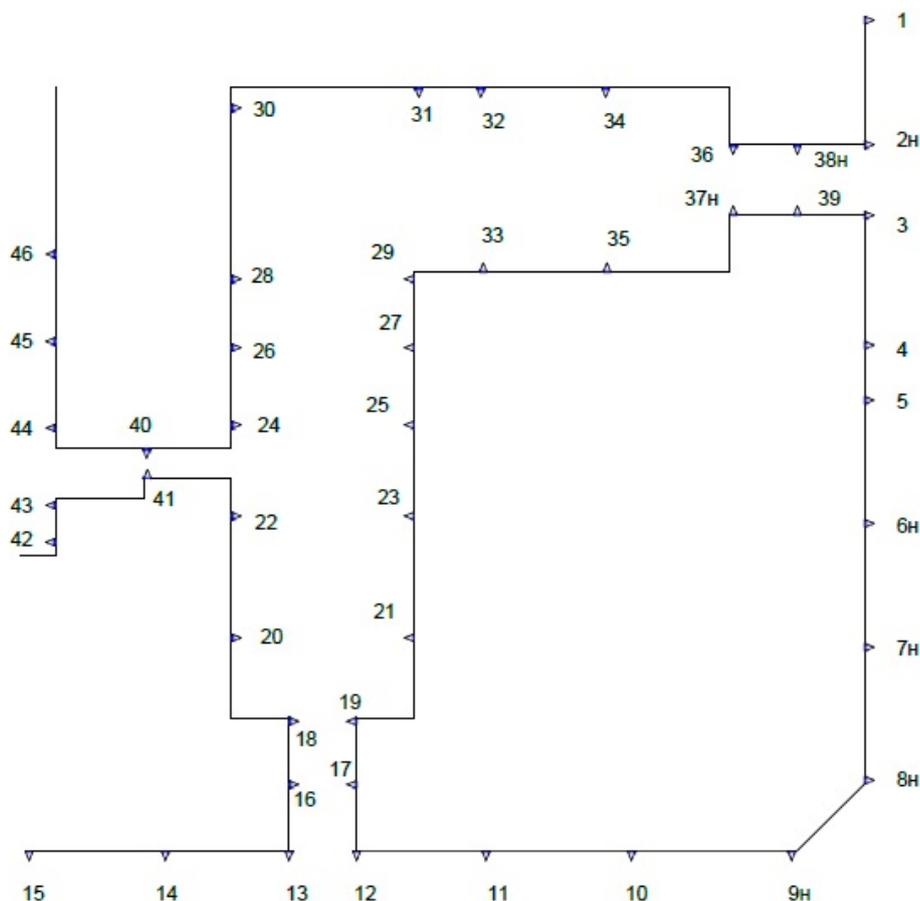
Pic. 6. «Deformation marks arrangement»

From the obtained results it follows that from August 26, 2017 to 07.03.18 the building sludge was practically absent with the exception of grades 12, 13, 16, 17, 18, 19 from 3 to 9 mm, M37 and M38 - 12 mm and M29 - 30 mm. There are no regularities in the development of precipitation, except that the first two grades are in the sensitive structures of the building-arches, and the M29 sediment is probably associated with reinforced concreting to strengthen the foundations of the "Passage's" interior with the use of jackhammers in conjunction with existing foundations.

4. It is advisable to install deformation marks inside of the building as an arch and as an along the perimeter of the exterior wall of the building from the east side.

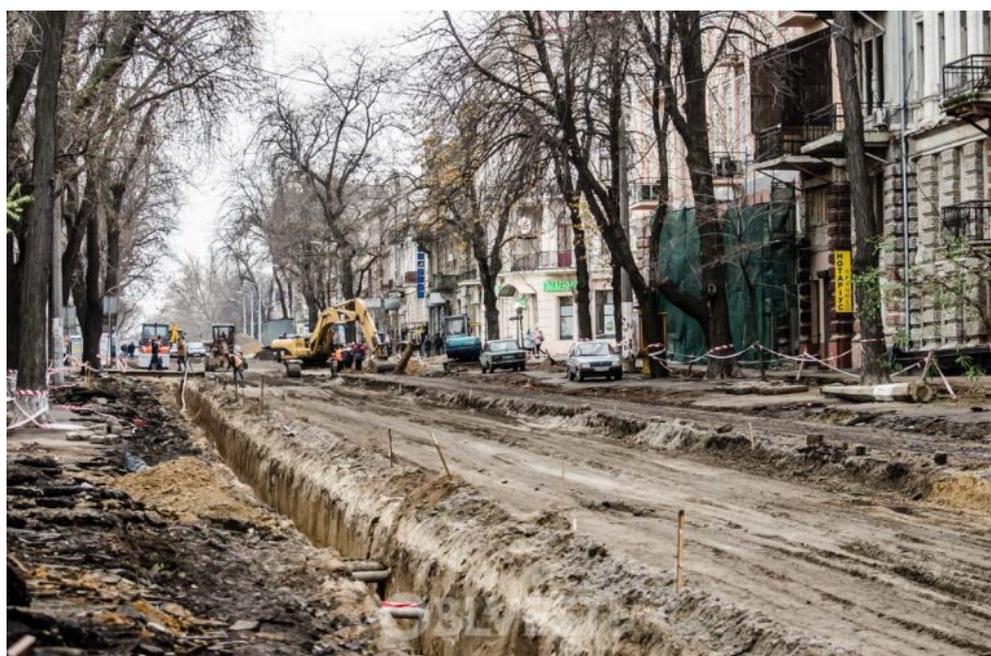
However, in 2016-2017 years the capital reconstruction of the road surface and communications of the street of Preobrazhenskaya with excavation up to 1.5 m (pic. 7-8), which probably influenced condition of the building. [4-7]

Pic. 7. «Reconstruction of the Transfiguration Street in 2017»

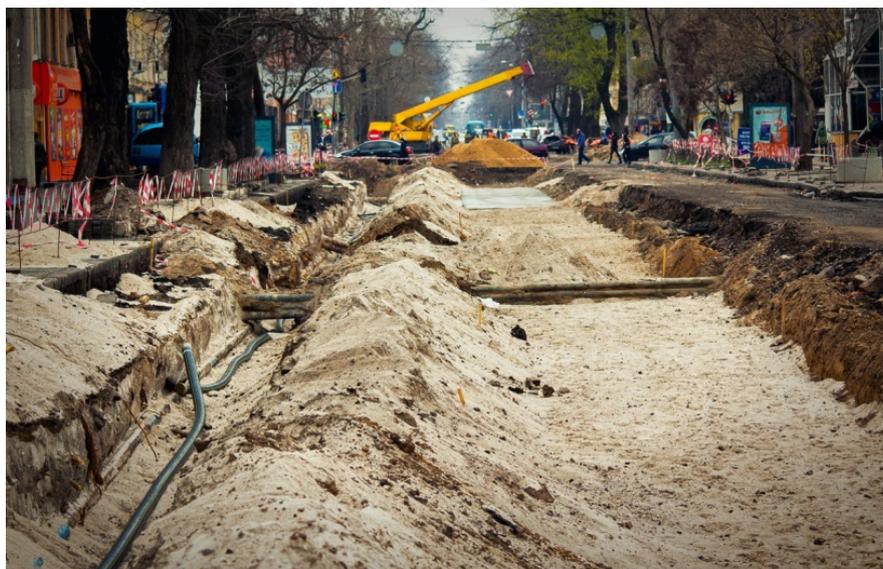
Pic. 8. «Replacement of engineering networks near the "Passage"»

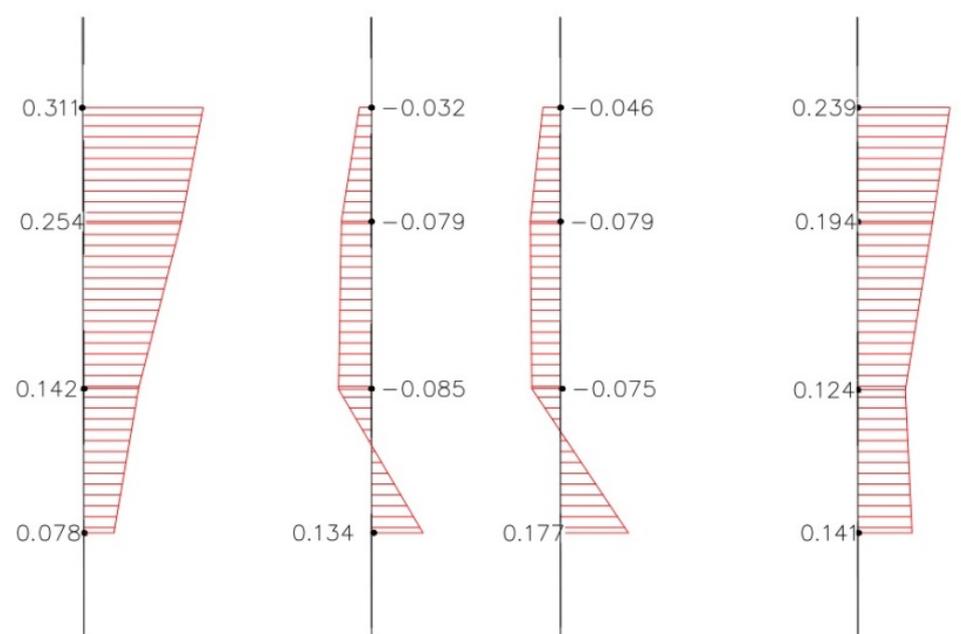
From the results obtained, it follows that the deviation of the walls from the side of Deribasovskaya ranges from 0 to 125 mm. At the same time, there are no regularities in the deviation of the building walls. The maximum deviation of the wall along the vertical is 125 mm. A significant variation in the deviation of the walls in the planned position takes place along the facade from the side of the Preobrazhenskaya Street. The deviation of the wall varies from 0 to 311 mm in the level of the fourth floor. Part of vertical deviations the middle of the building wall from the Preobrazhenskaya street in pictures 9.

Pic. 9. «Part of vertical deviations the middle of the building wall from the Preobrazhenskaya street»

3. The maximum deviation of the roll from the side of the Preobrazhenskaya Street is 311 mm. In addition, the value of the roll is within the limits permitted by regulatory documents.

5. The building of the "Passage" requires constant geodetic monitoring during the whole period of its reconstruction.
